Manhole Inspection Summary

Manhole # S27A__072MH

Insp Date: **4/27/09 12:19 PM**

Location Address: **703 EDMONDSON AVE**

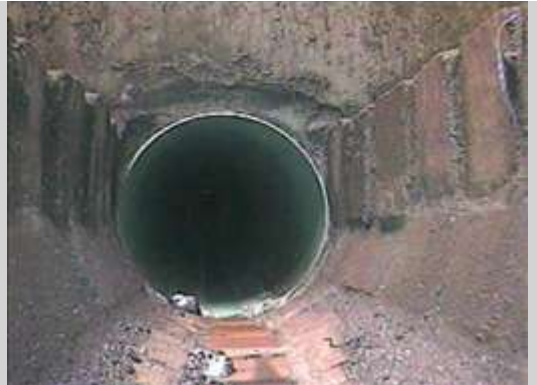
12 O'Clock Outflow

8 in. Circular Gravity Sewer
Pipe Out @ 12 O'Clock

Pipe Height: (in.) Direct
Pipe Material: **PVC** ☐ Pipe Lined
Invert Depth: **10.42** (ft.) Flow Characteristics: **Slow**
Deposits: ☒ None ☐ Mud ☐ Sludge ☐ Debris ☐ Grease
Silt Depth: (in.) Deposits Extent:
Infiltration: **None** Pipe Seal Cond: **Sound**

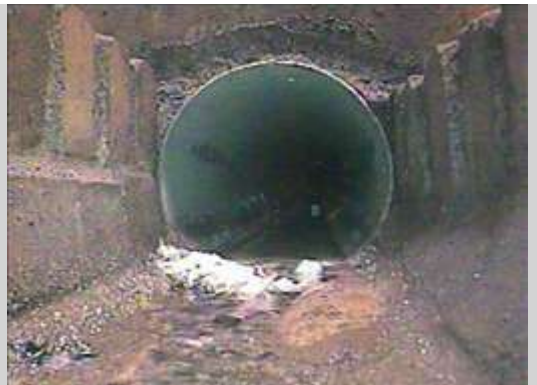
6 O'Clock Inflow

8 in. Circular Gravity Sewer
Pipe In @ 6 O'Clock

Pipe Height: (in.) Direct
Pipe Material: **PVC** ☐ Pipe Lined
Invert Depth: **10.50** (ft.) Flow Characteristics: **Slow**
Deposits: ☒ None ☐ Mud ☐ Sludge ☐ Debris ☐ Grease
Silt Depth: (in.) Deposits Extent:
Infiltration: **None** Pipe Seal Cond: **Sound**
